## DEGREE IN TECHNICAL ARCHITECTURE AND BUILDING FINAL DEGREE PROJECT

### FIRE SPREAD ACROSS INNER COURTYARDS FAÇADES

**Author:** Esteve Gonzàlez Cuxart

**Call:** April 2020

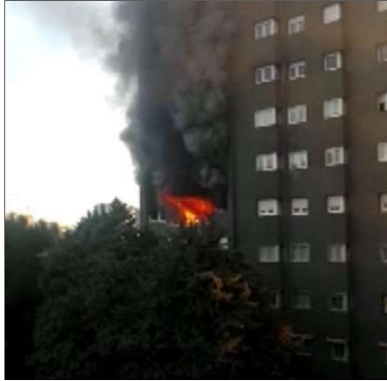
Figure 26. 2019.03.03 Housing fire in Chile street in Barcelona started at 07:33 AM with the result of two fatalities (La Vanguardia).

Figure 26: A virulent fire declared at dawn burns the entire floor causing the death of the two people staying on the floor. Despite the spectacular flames, the closed door did not cause any personal harm to any other inhabitant or materials to any other part of the building, as declared by the Day Fire Chief Barcelona.

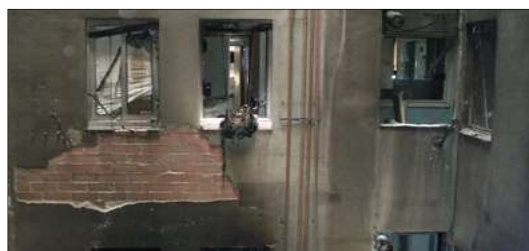
Firefighting crews did multiple rescues of trapped occupants using 2 turntable ladders. The other building occupants remained at home during extinguishing tasks accompanied by firefighters. The fire spread through the light patio and the stairwell and it was so extreme that building's electrical, gas, and water service were damaged as well as all flat doors. There was no damage to the structural integrity of the building.

View of the damaged light patio (CCMA).

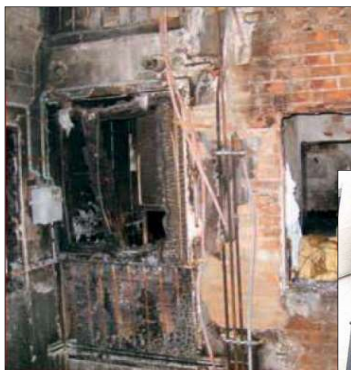
Eight over eighteen flats were affected in a different degree. Gas, and water services were damaged, causing 26 occupants to be moved out from the building.

Gas service damaged (Fahrenheit451).

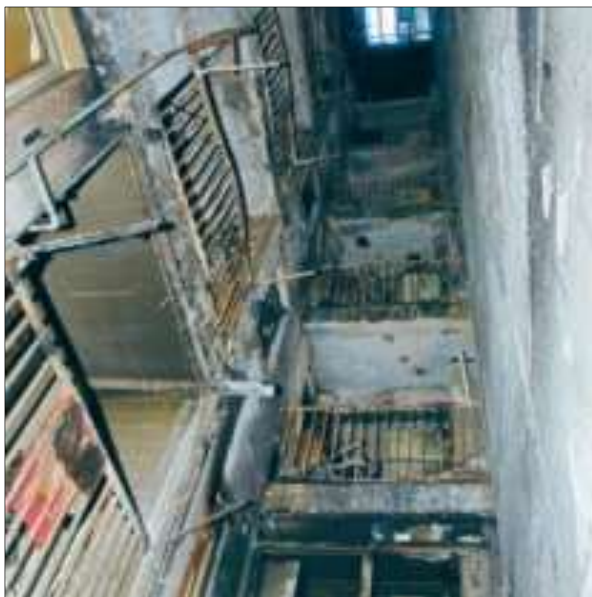
When firefighters arrived on the scene, the fire was fully developed on the 2nd floor. According to the owner - the fire was caused by the explosion of a television - spreading throught the airy patio going up and down. The fire affects the gas facilities which spreaded fire focus along the eight floor galleries. The seventh attic door was completely burned and building's electrical, gas, and water service were damaged.

The fire spreads through the airy patio at 594 Còrcega St (Farenheit 451).

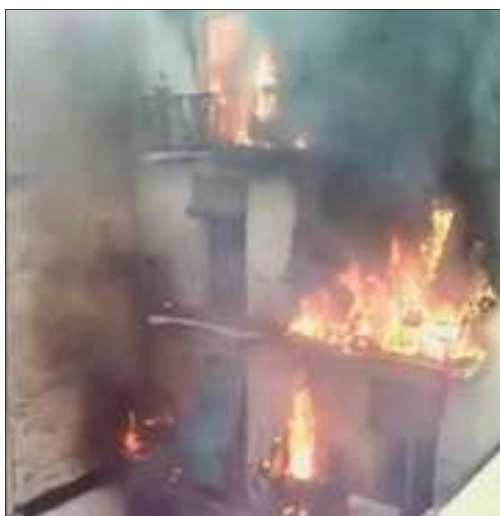
Ten of the eleven flats were affected in a different degree, and two of these completely burned. On the ground floor, the fire progressed inside a musical bar burning a soundproof room located at the back. Firefighters worked to remove the soundproof wall panels to locate and extinguish the fire.

Fire spreading on the inner courtyard of the block (CCMA).

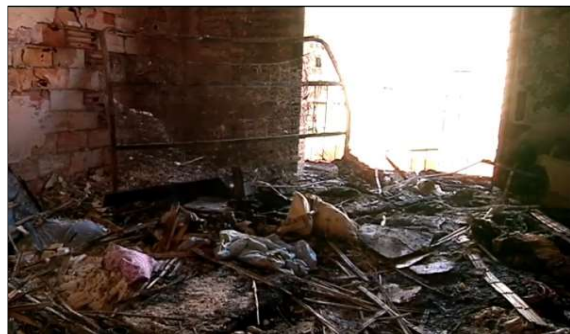
When firefighters arrived on the scene, the fire was fully developed on 3rd floor and spread through the airy patio. All first and third door flats were affected in a different degree as well as the B stairwell. The gas service was damaged.

The third floor flat burned (Betevé).

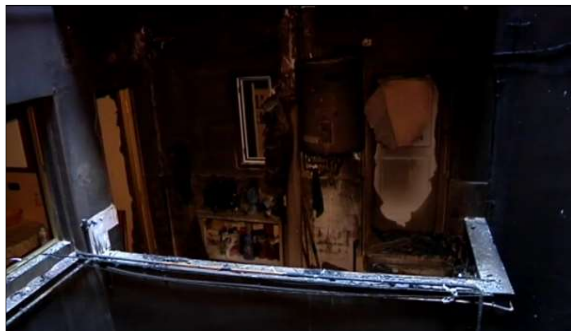
Gallery affected by the fire (Betevé).

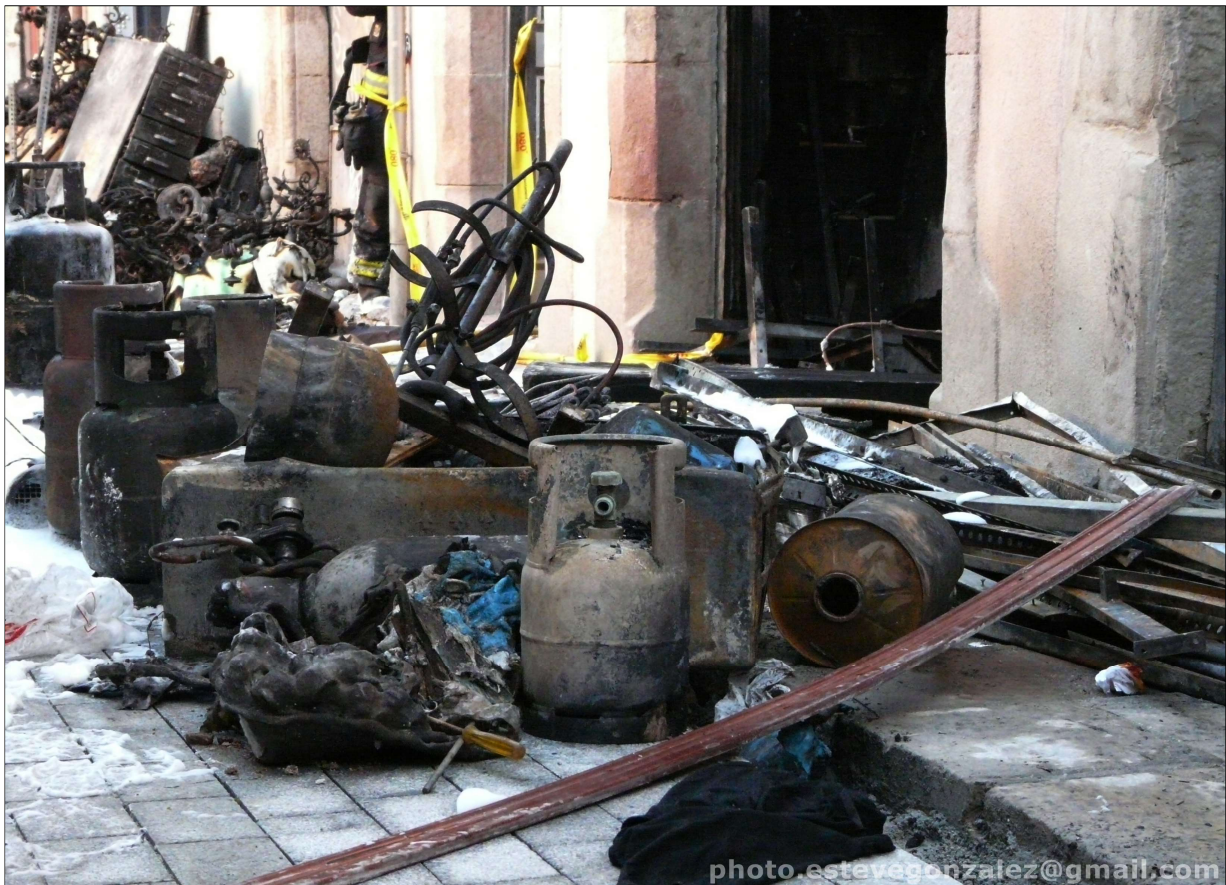
2014/12/16 Gazz cilinders inside the premises set on fire at 55 Jaume Giralt St (Author).

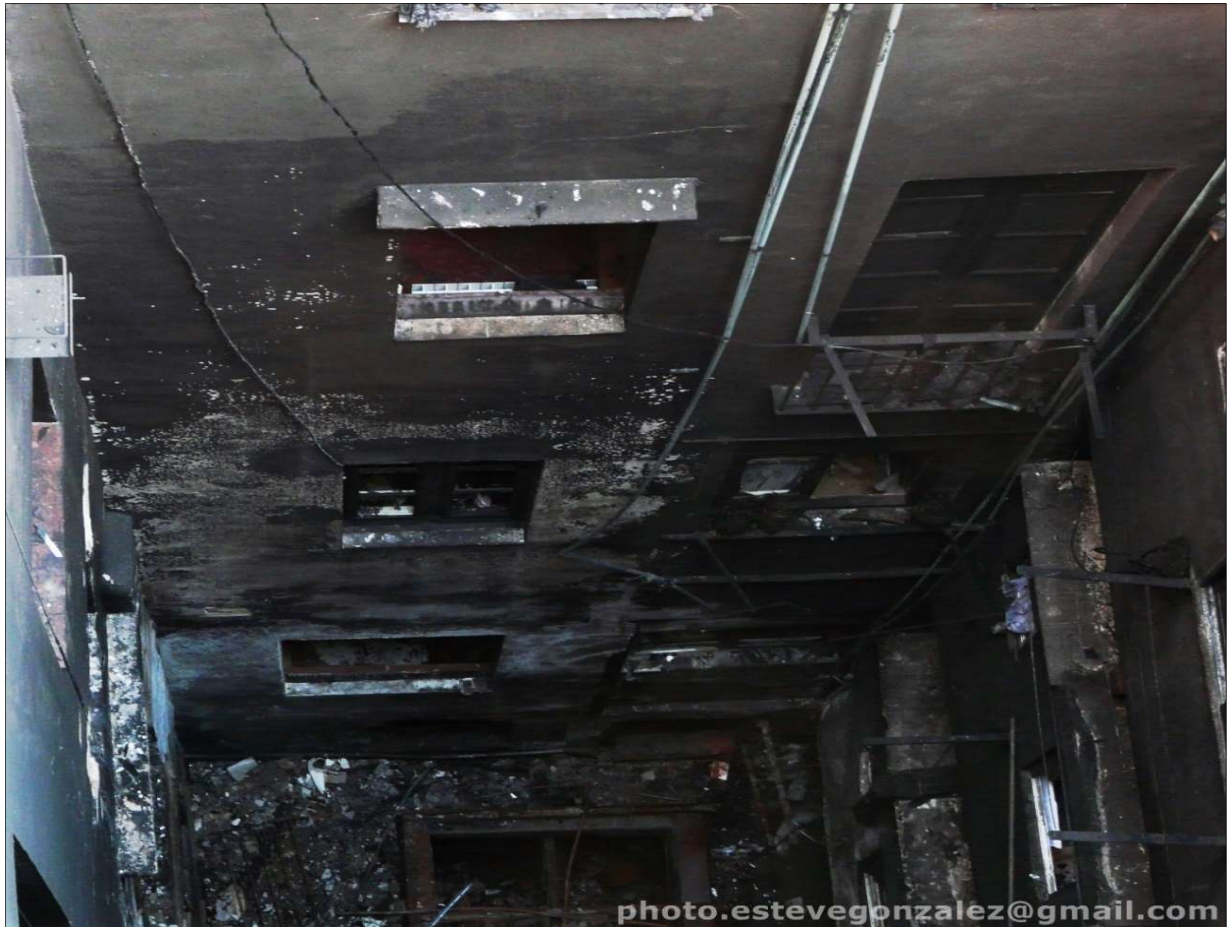
2014/12/21 Burned light patio seen from the roof of the Hotel (Author).

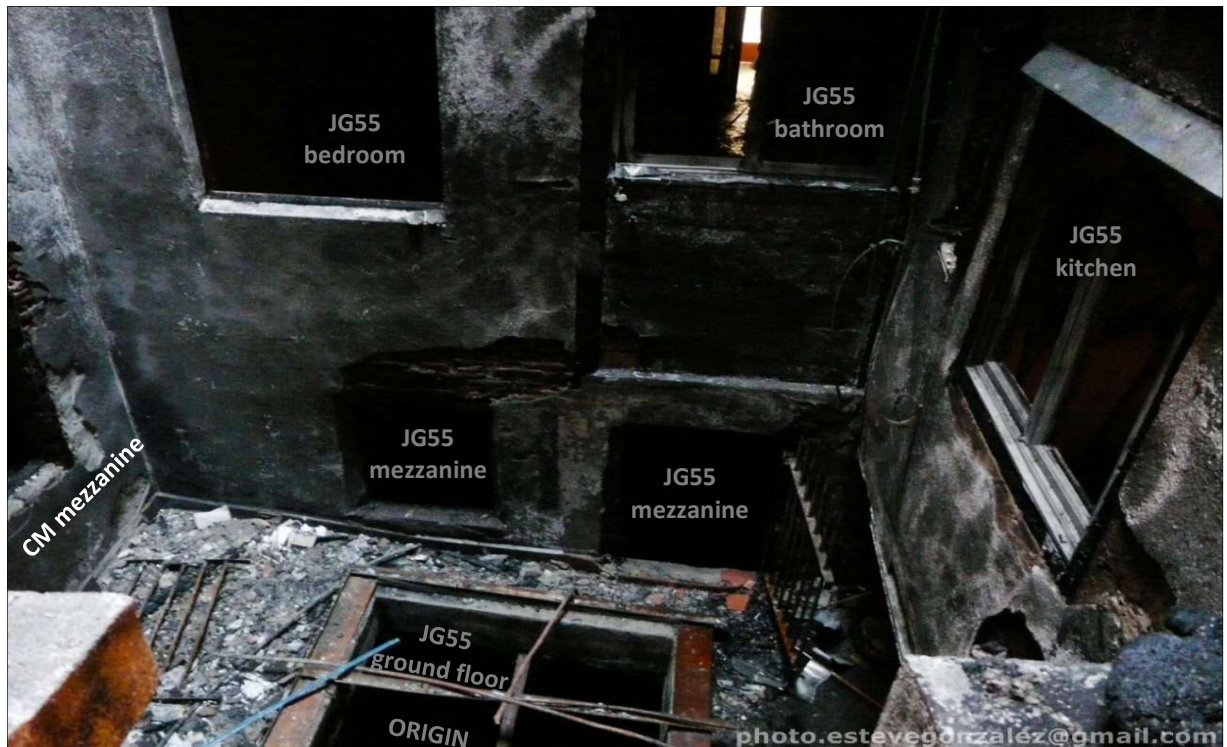
2014/12/21 Burned light patio seen from the protected staircase of the Hotel (Author).

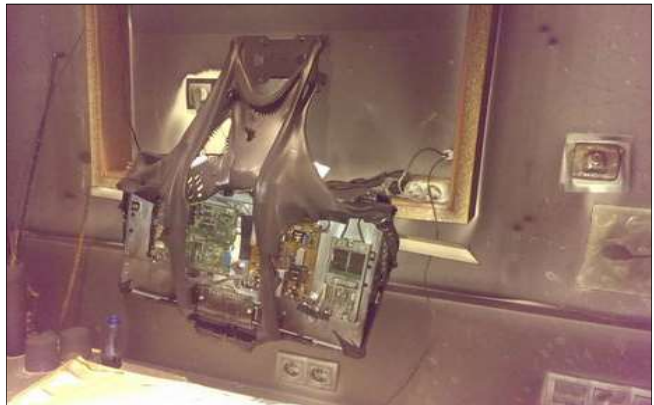
2014/12/21 Hotel room, flat screen TV impacted by temperature (M.Sellarès).

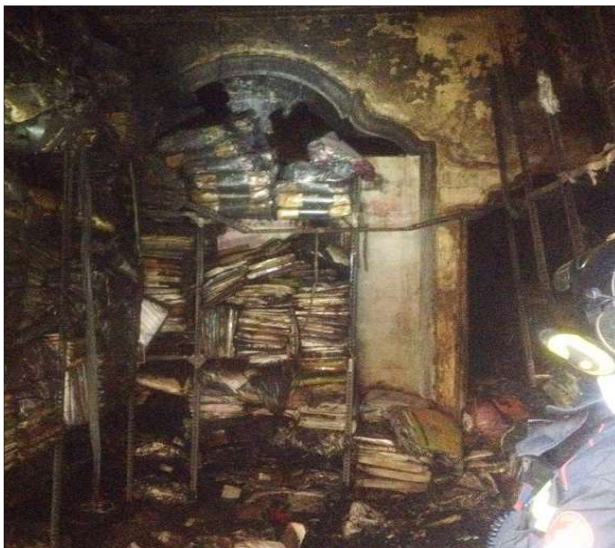
2014/12/17 Casa de les Mantes, first floor affected (M.Sellarès).

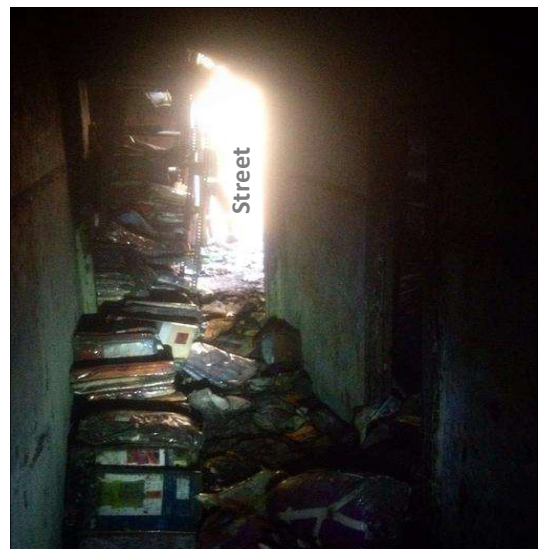
2014/12/17 Casa de les Mantes, first floor affected (M.Sellarès).

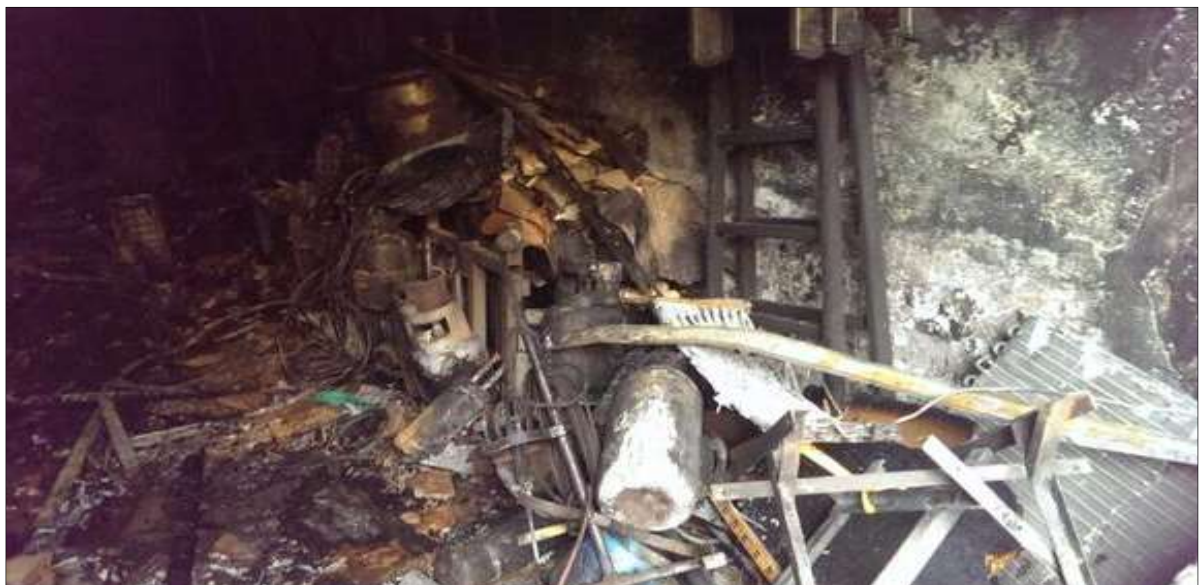
2014/12/17 55 ground floor at 55 Jaume Giralt St, origin of the fire (M.Sellarès).
